Feasible Restoration Proposal of El Yunque National Forest Structures

Project Number: IQP FB 900
An Interactive Qualifying Project
Submitted to the Faculty of
WORCESTER POLYTECHNIC INSTITUTE
in partial fulfilment of the requirements for the
Degree of Bachelor of Science

Abstract

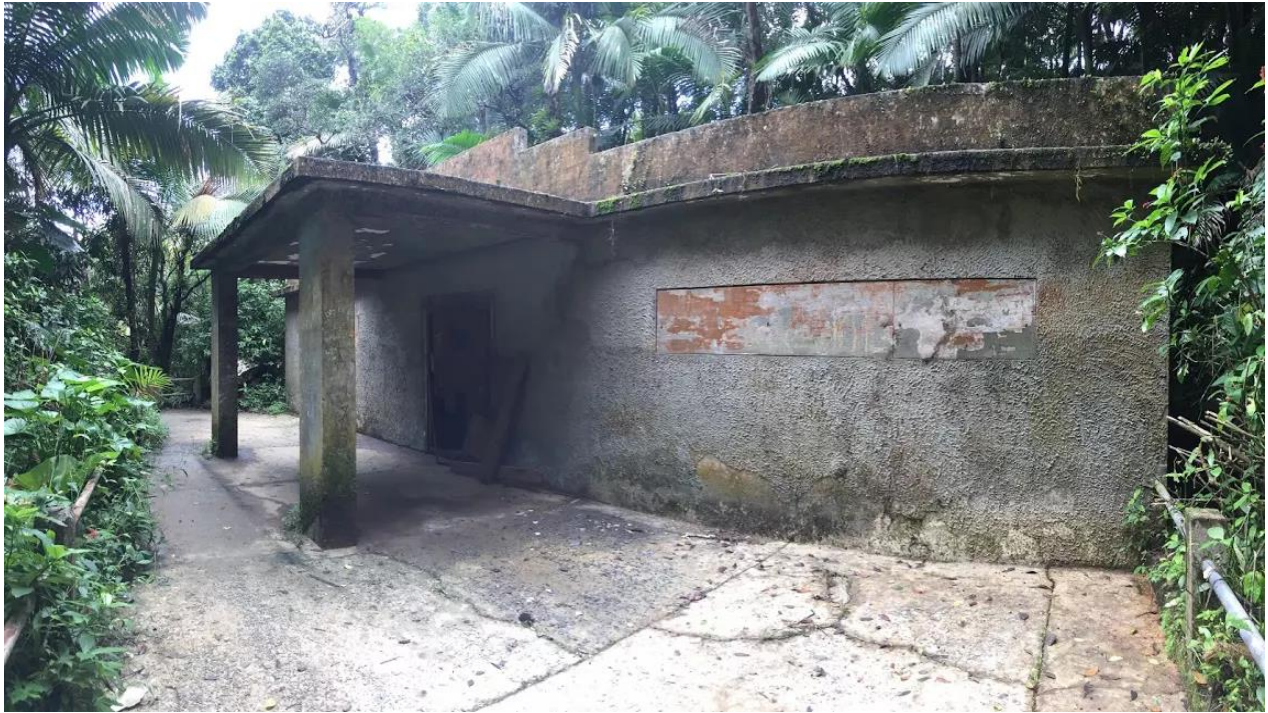
Figure 3: Baño Grande Bathhouse

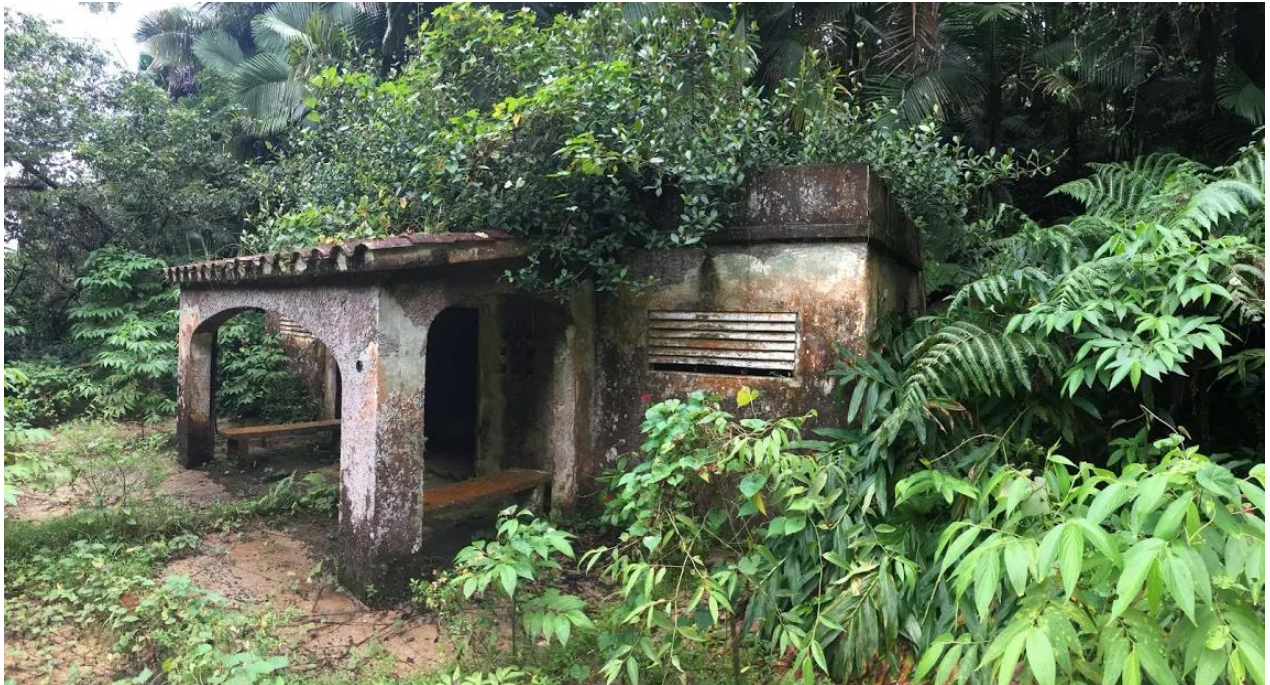
Figure 5: Baño de Oro Bathhouse

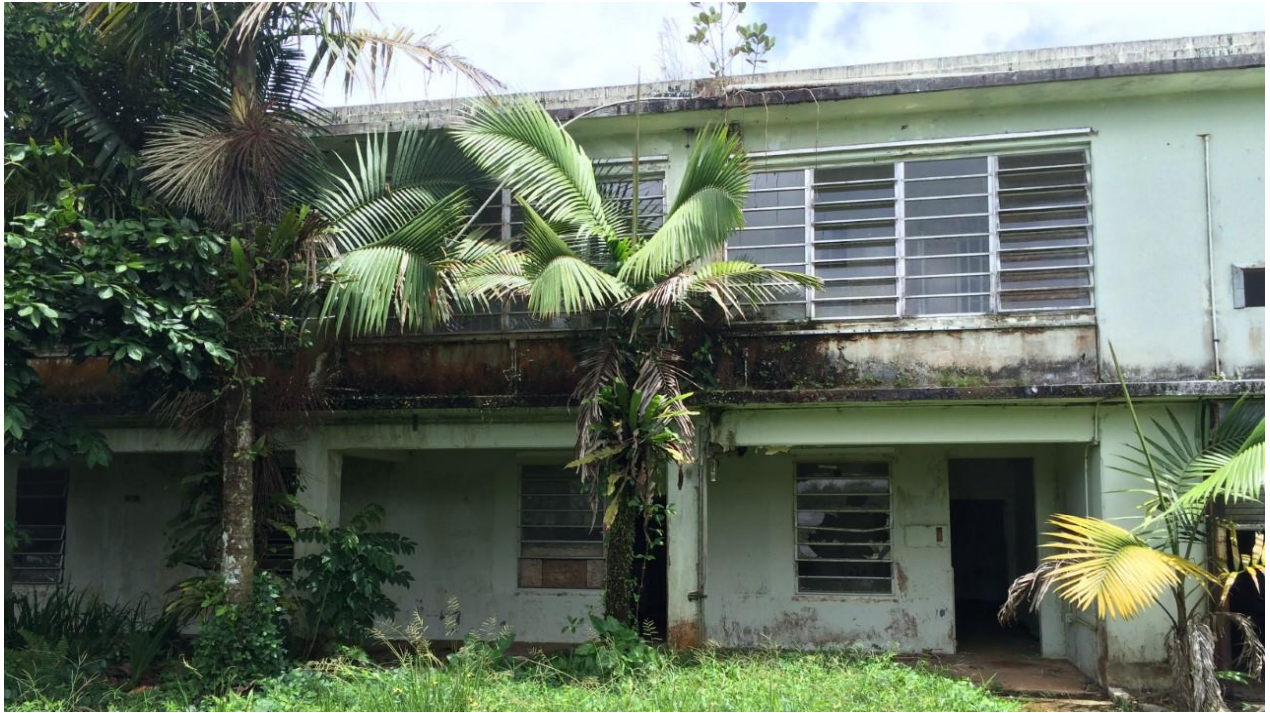
Figure 7: Army Barracks

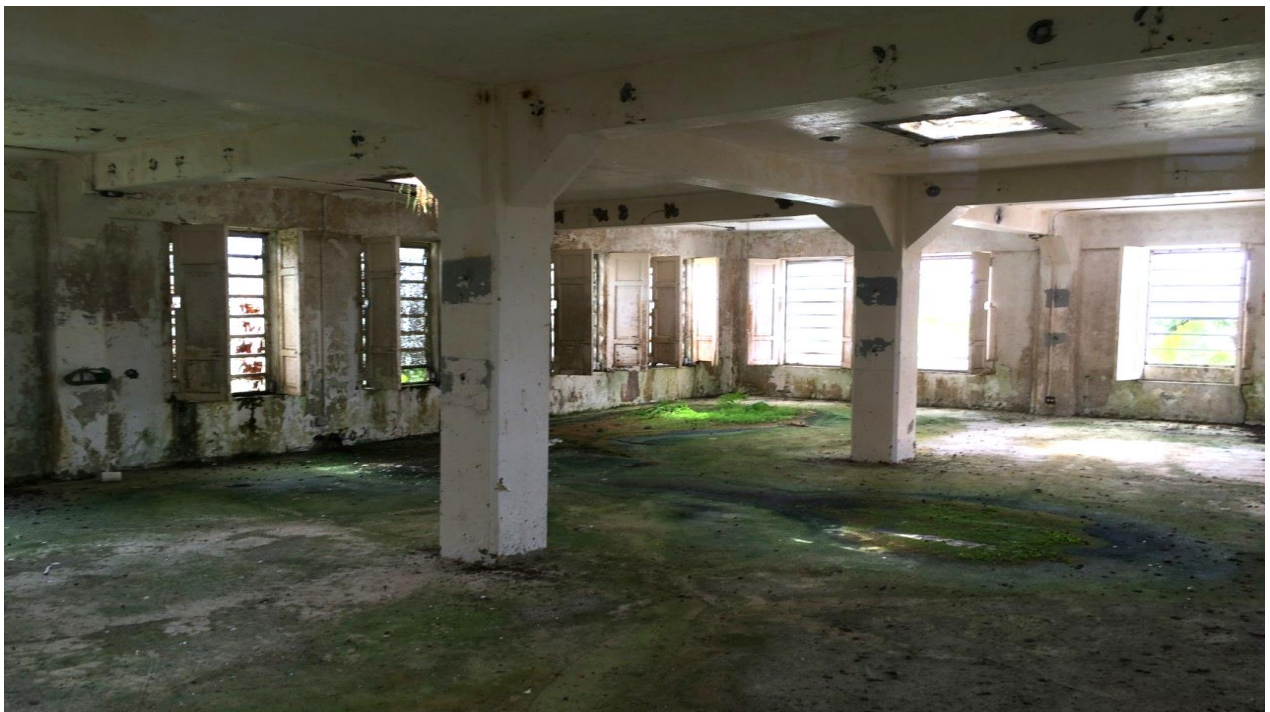
Figure 8: Inside of Army Barracks

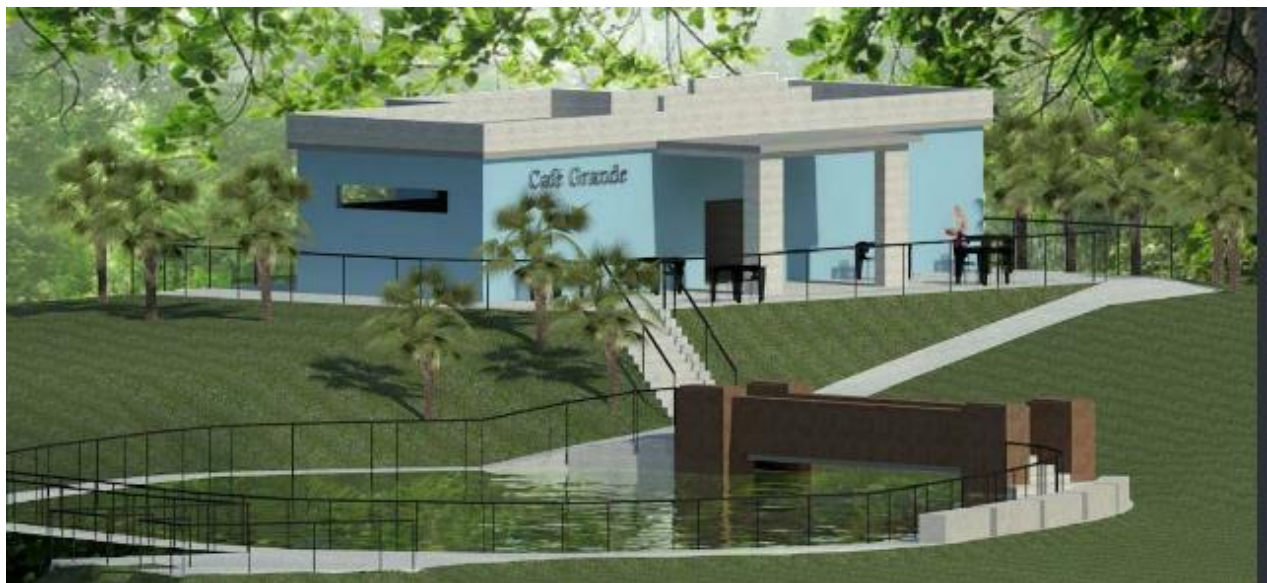
Figure 12: 3D Render of Baño Grande

our sponsor as well as all USFS employees. The 3D renditions of the three sites can be viewed in Figures 12-14, and additional, more in depth renditions can be found in Appendix F.

Using AutoCAD, we recreated more accurate versions of the blueprints the USFS had of both Baño Grande and Baño de Oro using our own field measurements. There weren't any existing blueprints for the army barracks available to us because the United States Army did not release them to the USFS. Once the new blueprints were drawn, we used them as an overlay in Revit so the dimensions were consistent. In Revit, we attempted to recreate the structures with the same materials found on site. We used a lot of computerized concrete for our rendered designs because this is one of the materials we found to be least likely to deteriorate quickly in the aggressive rainforest atmosphere. For our Baño Grande design, we rendered an arbitrary version of the pool because that remains unchanged in our plans. The Baño Grande bathhouse was rendered to be painted and rid of excess vegetation around the site. The front patio was extended for lounging and a handicap accessible ramp was added. The final design had two rooms on either side of a café that would be multipurpose rooms to be used by the USFS, boy scouts, or possibly the public.

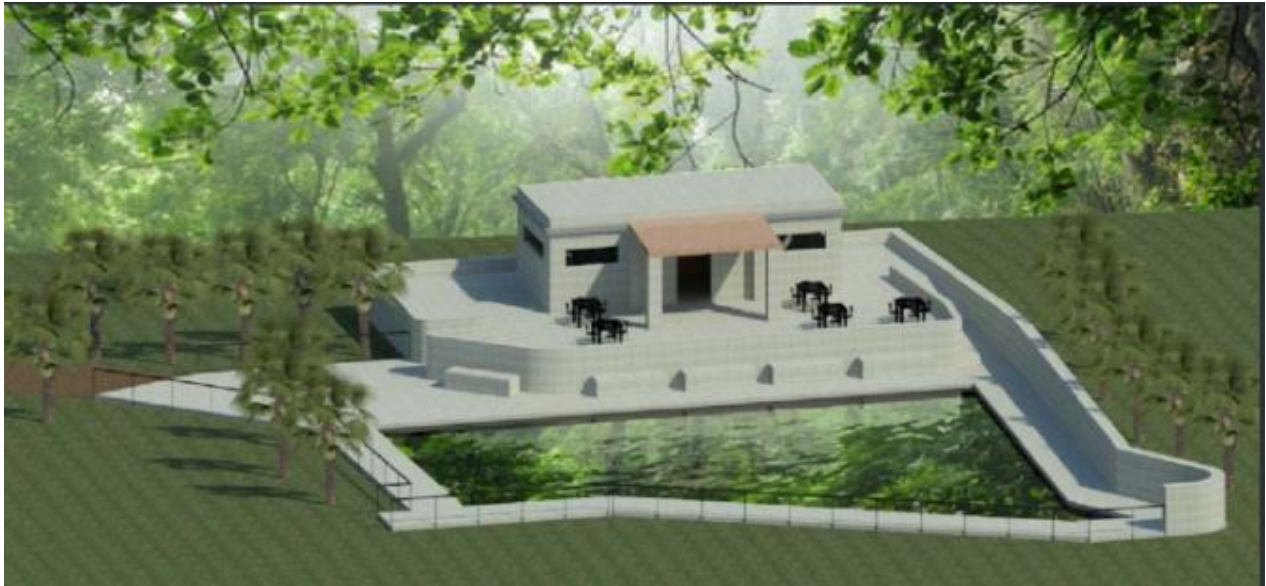
Figure 13: 3D Render of Baño de Oro

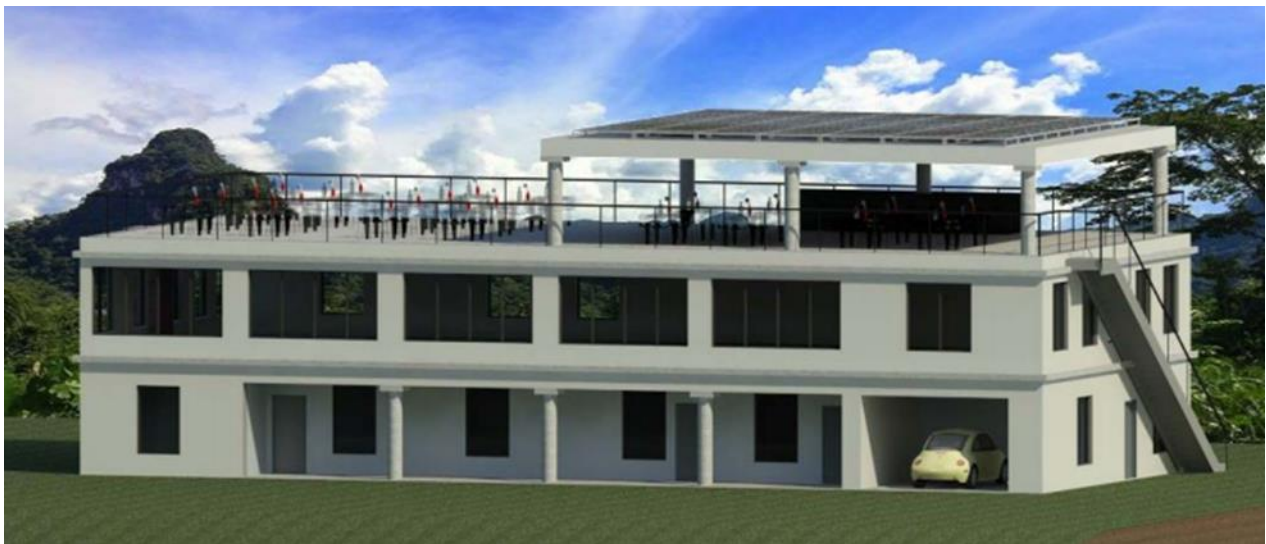
Figure 14: 3D Render of Army Barracks

The design for the Army barracks was to create it into a hostel. Our design exhibits large rooms with multiple beds and communal bathrooms and kitchens. There is a room for a live in employee and a garage for them as well. The roof was converted into a rooftop bar with half of the area covered by an added ceiling for coverage during disagreeable weather. On top of this added ceiling we added solar panels to fuel backup generators in the case of a power outage which can be very common in the mountains of El Yunque. Finally, we rendered images inside and outside of all the structures and created realistic video walkthroughs.
